UNITED STATES ENVIRONMENTAL PROTECTION AGENCY

SUBJ: EPA Asbestos Removal at 225 Eden Street

REMOVAL ACTION STATUS REPORT DAVIDSON ASBESTOS

Property Address: 225 Eden Street, Davidson, Mecklenburg County, North Carolina

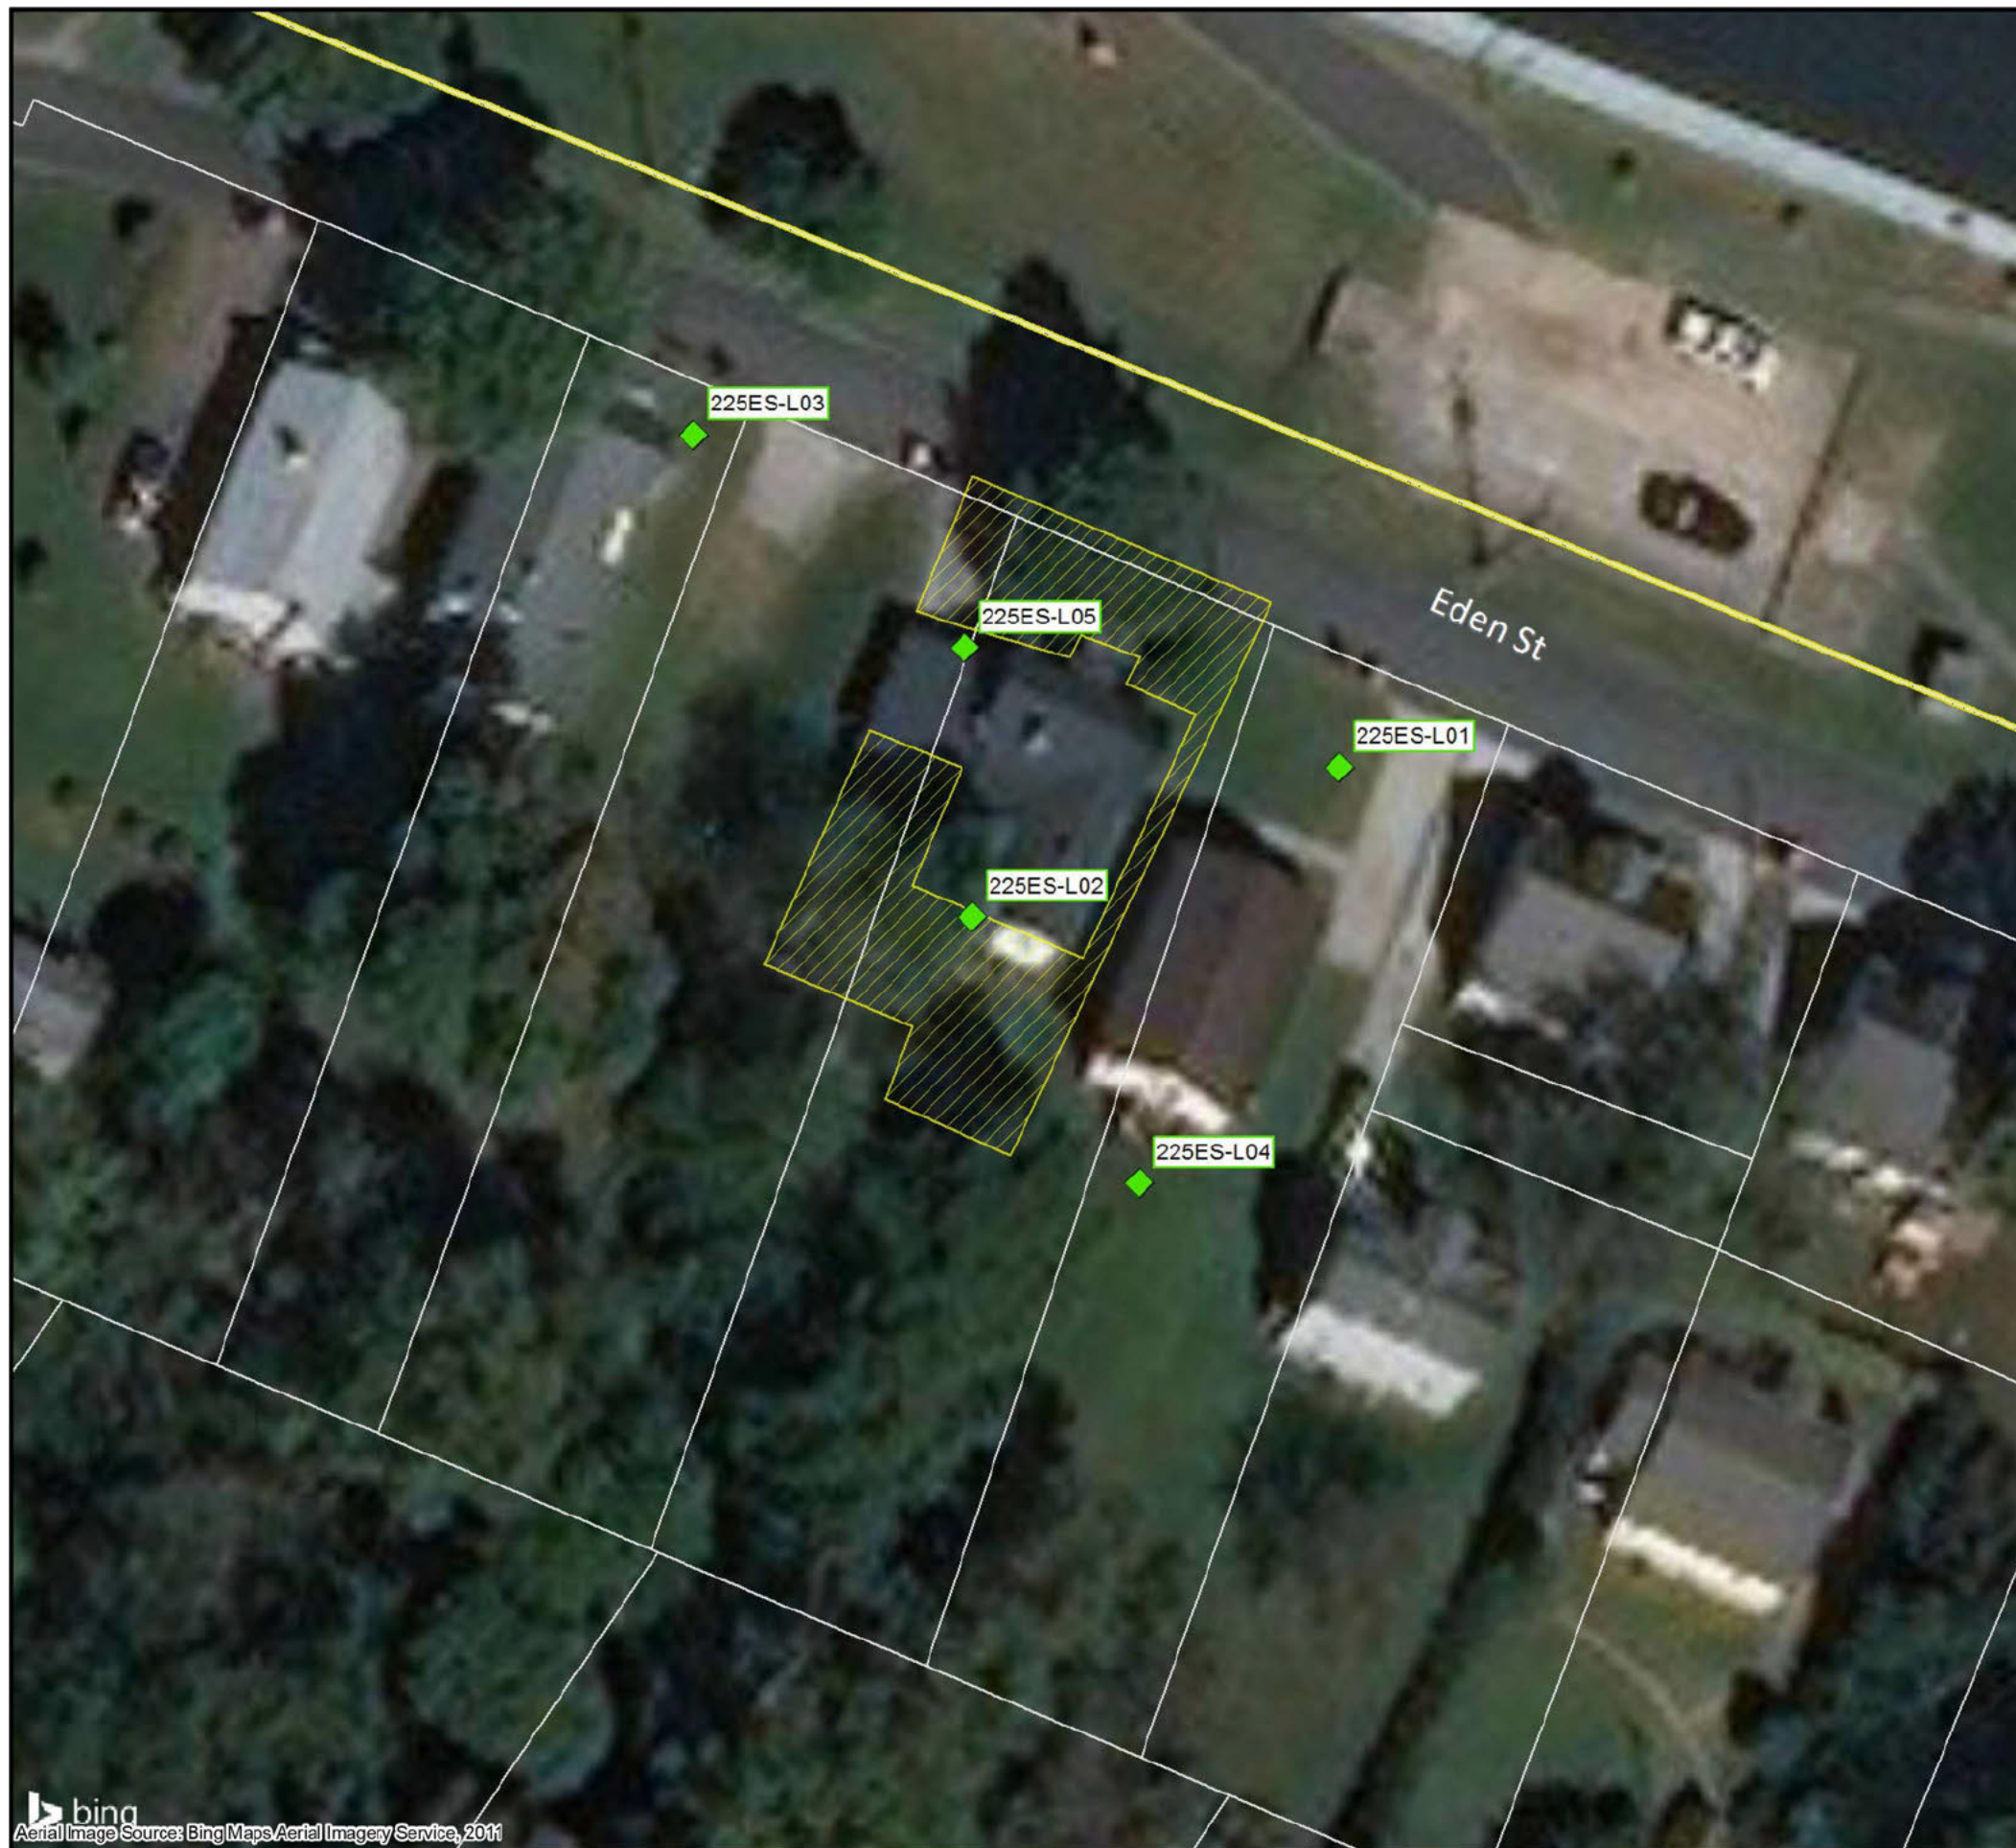
FIGURE 1

Removal Areas and
Air Sampling Locations

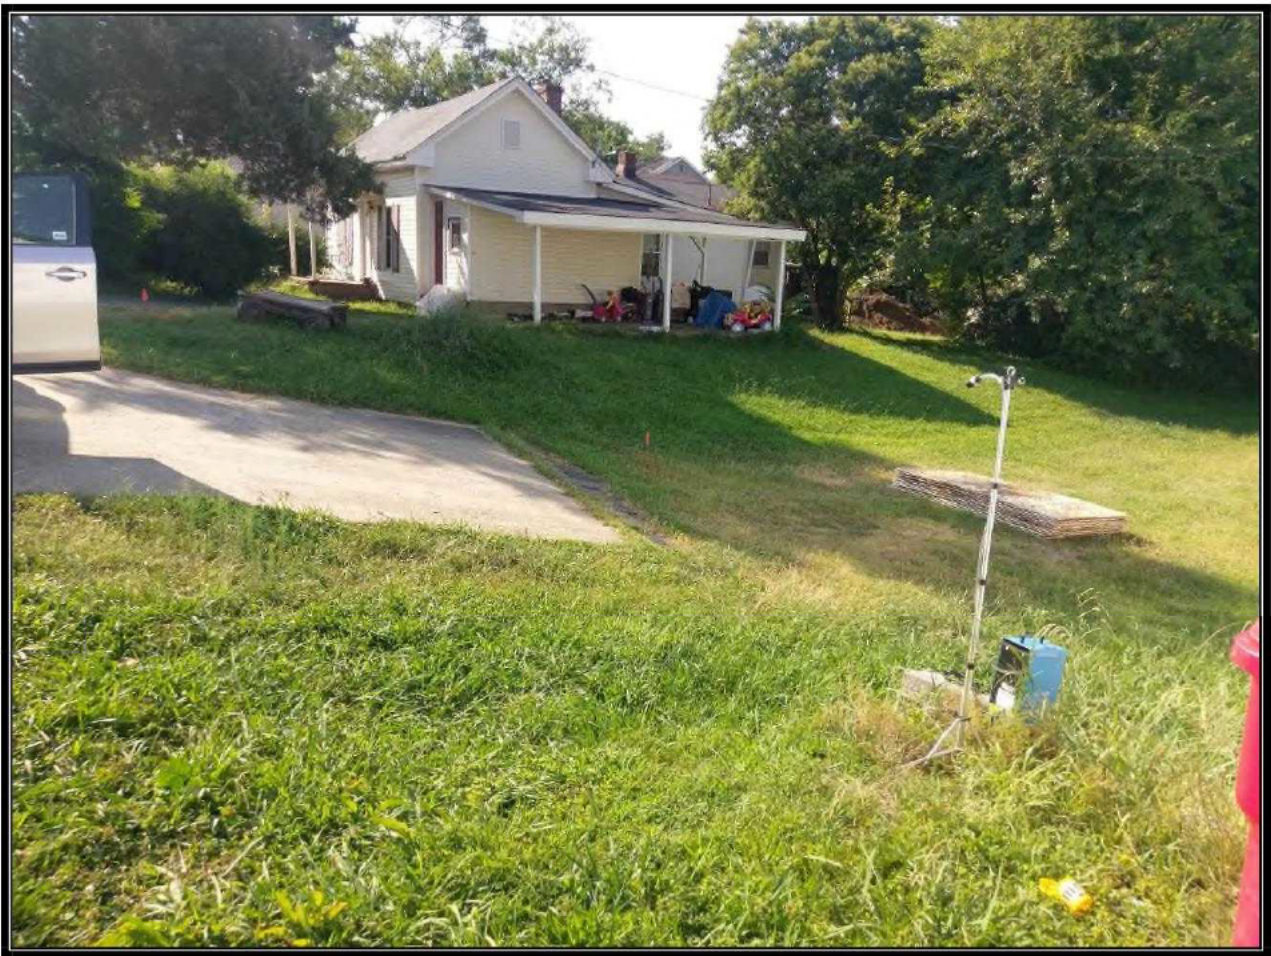
OFFICIAL PHOTOGRAPH NO. 6
U.S. ENVIRONMENTAL PROTECTION AGENCY

Subject: Perimeter air sampling was conducted by a Tetra Tech START, State of North Carolina-accredited air monitor, to evaluate the effectiveness of engineering and safety controls in preventing the off-site migration of asbestos fibers during removal activities.
